Emissions Recall

Code: 24CV

Subject Inlet Air Box Housing Snow Flap Replacement & Oxygen Sensor Inspection/Replacement

Affected Vehicles U.S.A. : 2009-2014 MY Volkswagen 2.0L TDI Engine Vehicles (Generation I)

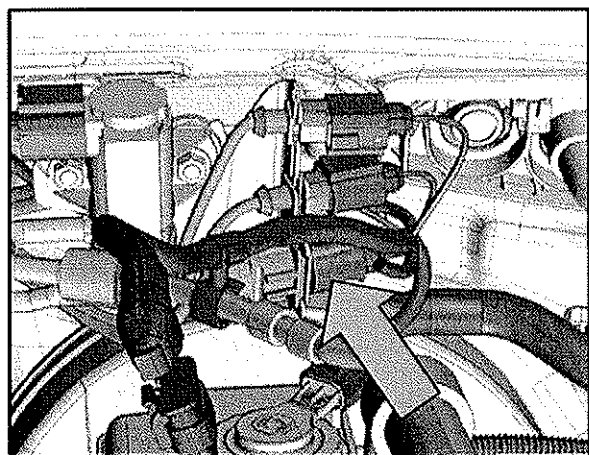
Fig 1.

- If the message "The Heated Oxygen Sensor -G39- is OK. No further action is required." <Fig 1> is displayed, then the Heated Oxygen Sensor -G39- has passed the self-check and does not require replacement.
 - **Proceed to Section C** to replace the Snow Flap.
- If the message "XXXXXXXXXXXXXXXXXXXX" is displayed, continue to the next step to replace the Heated Oxygen Sensor -G39- and rest the adaptation values using ODIS.
